# EVALUATION OF HARVEY TWO-PIECE LANDING MAT (AM2)

November 1966

Naval Air Engineering Center  
Philadelphia, Pennsylvania

U. S. Army Engineer Waterways Experiment Station  
CORPS OF ENGINEERS  
Vicksburg, Mississippi

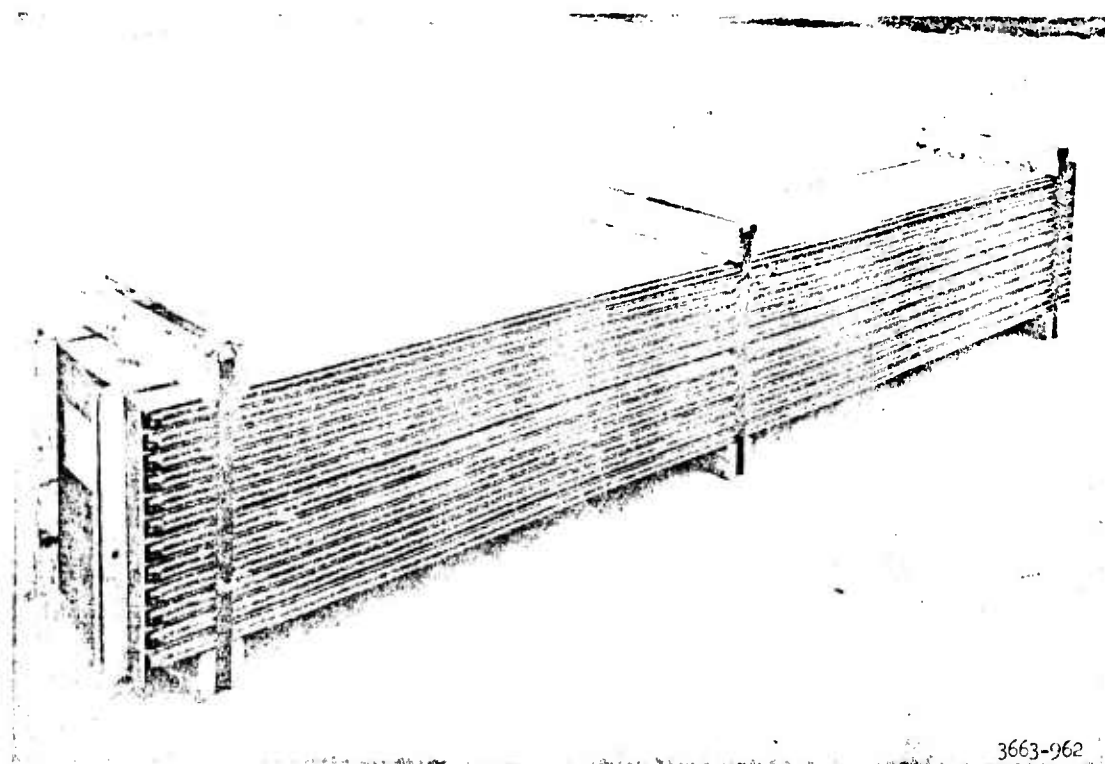
a. Bundle

b. Full and half plank

Fig. 1. Bundle and planks of Harvey two-piece AM2

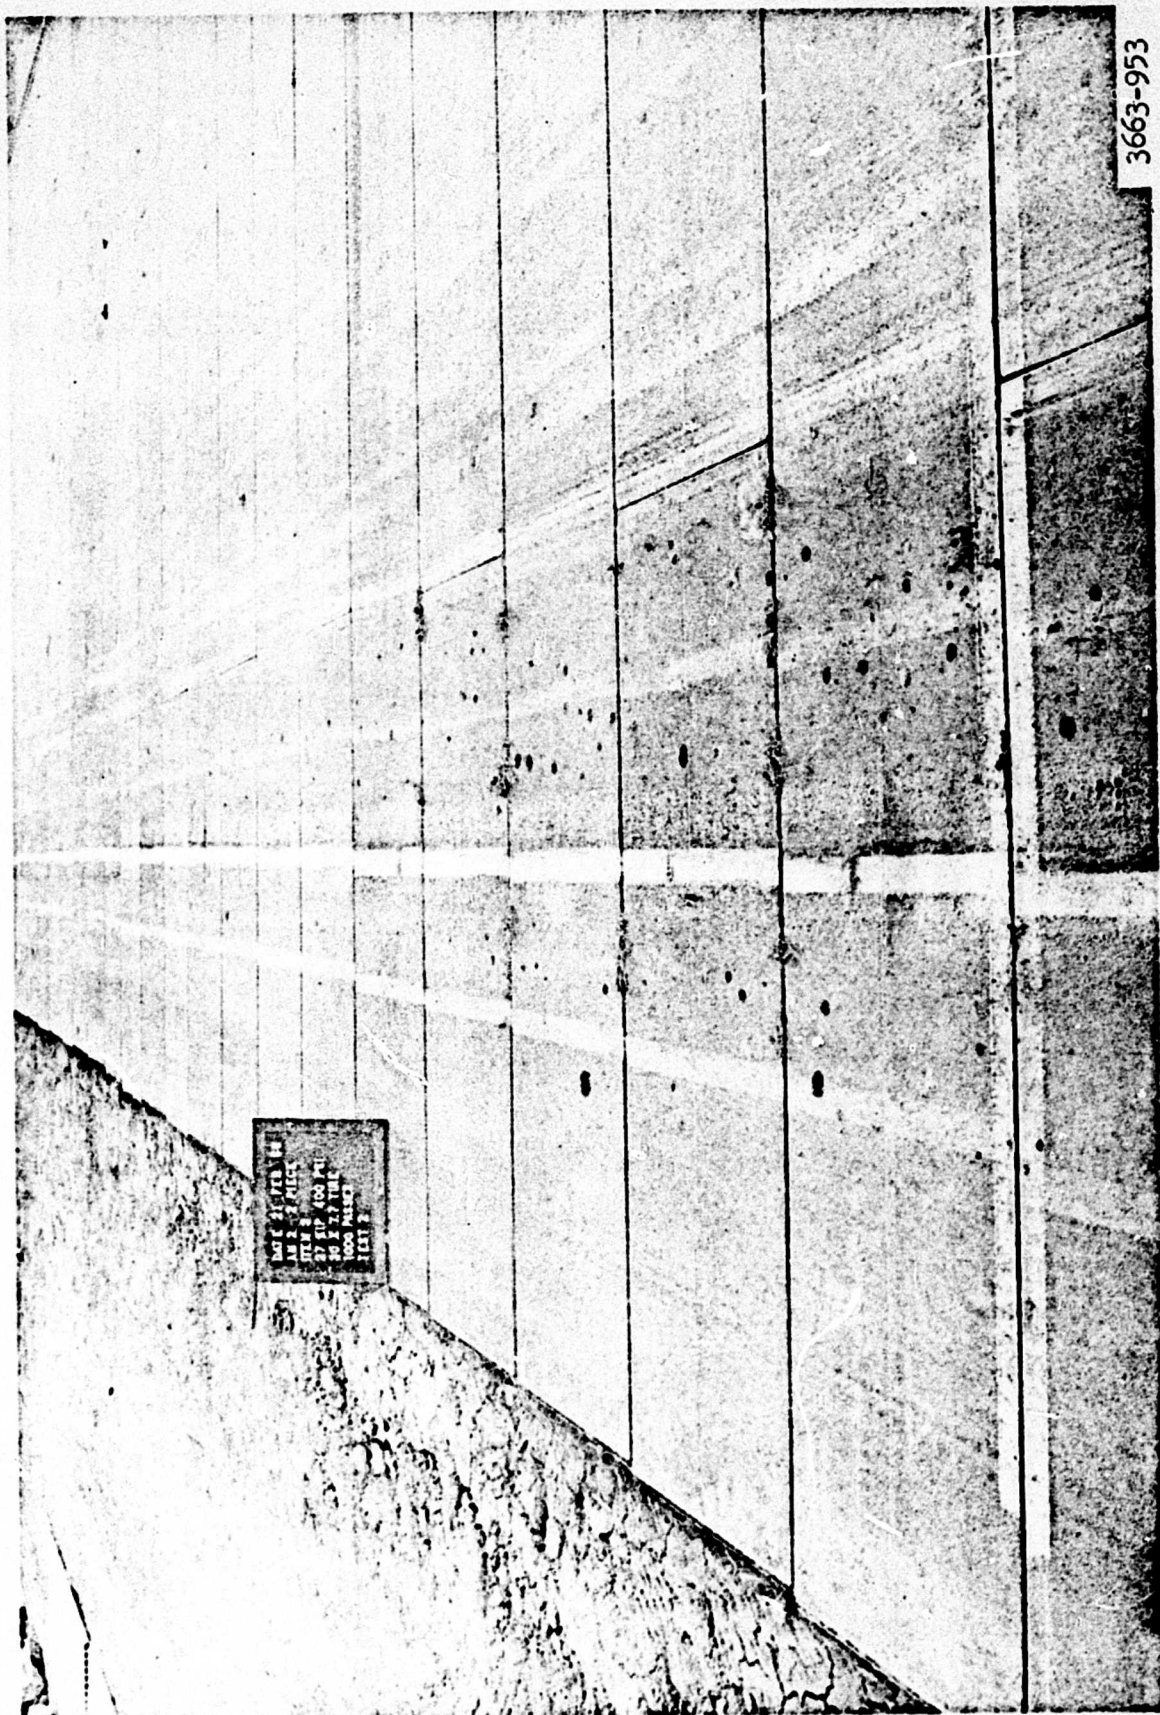
30. Some mat distress was noted in test items 2 and 4 at the end of 1000 passes, but little or no distress was noted in test item 3. Views of items 2, 3, and 4 at the end of 1000 passes of the load wheel are shown in photographs 11, 12, and 13, respectively. As traffic was continued, rapid deterioration of the mat in items 2 and 4 developed between 1200 and 1600 passes, and these items were considered failed after 1600 passes of traffic. The mat in item 3 was still in good condition when traffic was terminated. Test items 2, 3, and 4 at the end of traffic (1600 passes) are shown in photographs 14, 15, and 16, respectively. A typical longitudinal weld crack and dished planks indicating core failure are shown in fig. 5. One plank from each of the items was cut on the traffic lane center line. A cross-section view of each of these is shown in fig. 6. In the figure, planks 1, 2, 3, and 4 are from items 1, 2, 3, and 4, respectively, and are representative of the comparative damage suffered by each item by the end of traffic. It can be seen that the bottom weld had cracked in planks 2 and 4, whereas the top was still in good

Photograph 12. Lane 2, item 3, after 1000 passes
